**Flood Control Project Maintenance  
Levee Inspections**

## Maintenance Issue Types Only, Levee Inspection Report By Mile - Spring 2016

### Reclamation District No. 1001 Nicolaus

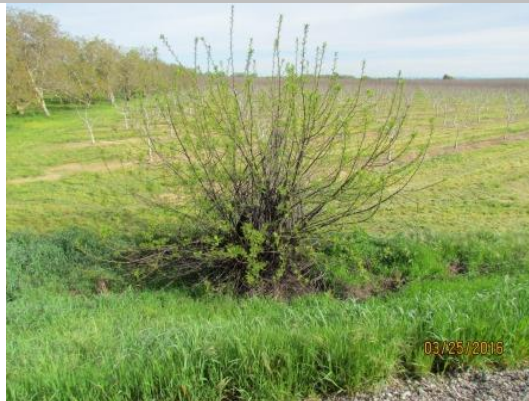
Photo 1 of 1 : SP\_2016\_RD1001\_36\_19\_20160404\_00012.jpg

View of tree that need limbs trimmed.

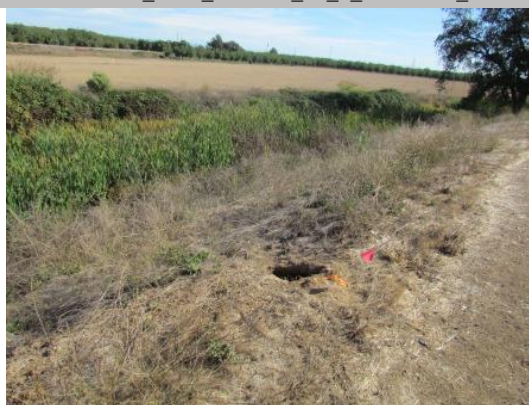
Photo 1 of 2 : SP\_2016\_RD1001\_35\_4\_20160307\_00001.jpg

LM Start	0.27	Rating **	A/W	Issue No.	4
LM End	0.27	Issue Type +	Ma	Location *	WS
Category	Earthen Levee			GPS Latitude/Longitude	
				Start	End
Item	Animal Control			38.974323 °	38.974323 °
				-121.476442 °	-121.476442 °
DWR ID	DWR_RD1001_02_f _ 2014_4				
Comment Code					
A3 : No rodents visible, but rodent burrows visible; need to backfill and compact or grout burrows.					
Inspector Comment					
There was an animal hole on waterward levee slope near the crown. Hole was approximately 1' in diameter and 8" deep but has been repaired, Spring 2016. This area should still be monitored for further animal activity.

This photo was taken from the levee crown facing east looking down the waterward slope at an animal burrow. Fall 2014.

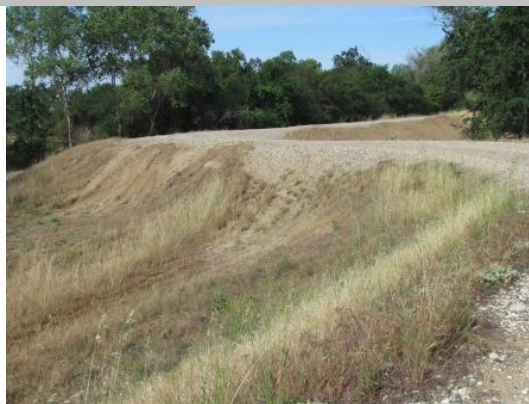
Photo 2 of 2 : SP\_2016\_RD1001\_37\_2\_20160307\_00003.jpg

View of the rutting on the landside of the levee facing upstream.

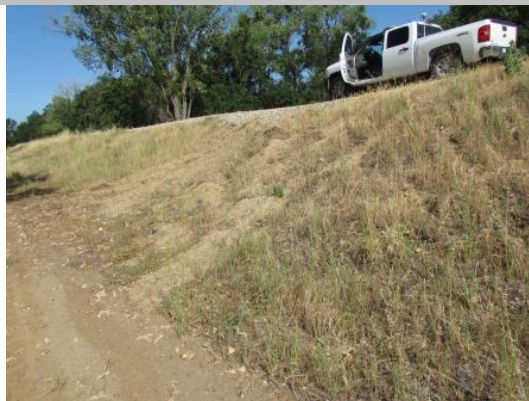
Photo 1 of 1 : SP\_2016\_RD1001\_37\_23\_20160307\_00011.jpg

LM Start	0.14	Rating **	M	Issue No.	23
LM End	0.14	Issue Type +	Ma	Location *	LS
Category	Earthen Levee			GPS Latitude/Longitude	
				Start	End
Item	Slope Stability			39.006351 °	39.006351 °
				-121.377313 °	-121.377313 °
DWR ID	DWR_RD1001_03_s_2015_23				
Comment Code					
S3 : Repair the levee slope damaged by vehicle traffic and prevent access where possible.					
Inspector Comment

View of the rutting on the landside of the levee from the toe facing downstream.

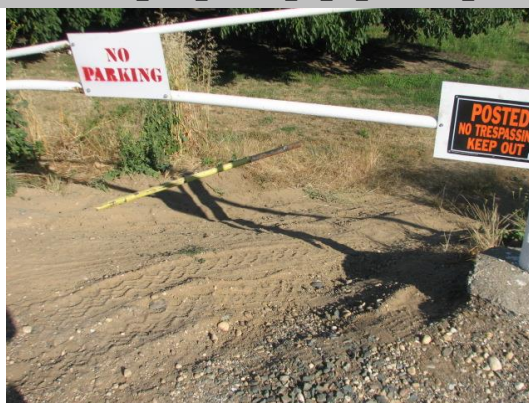
Photo 1 of 2 : SP\_2016\_RD1001\_37\_28\_20160307\_00013.jpg

LM Start	1.87	Rating **	A/W	Issue No.	28	
LM End	1.87	Issue Type +	Ma	Location *	WS	
Category	Earthen Levee			GPS Latitude/Longitude		
				Start		End
Item	Slope Stability			38.998608 °		38.998608 °
				-121.405570 °		-121.405570 °
DWR ID	DWR_RD1001_03_s_2013_28					
Comment Code						
S3 : Repair the levee slope damaged by vehicle traffic and prevent access where possible.						
Inspector Comment

Damage caused by vehicles Spring 2013

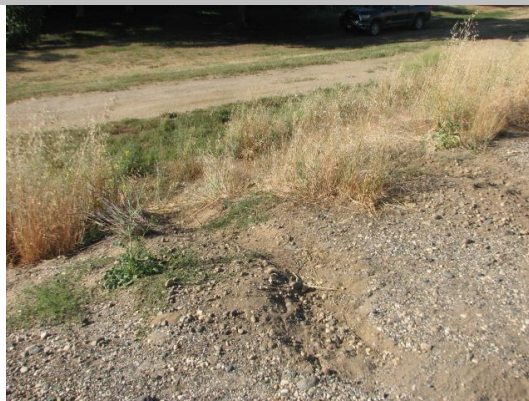
Photo 1 of 2 : SP\_2016\_RD1001\_37\_29\_20160307\_00015.jpg

LM Start	1.87	Rating **	A/W	Issue No.	29
LM End	1.87	Issue Type +	Ma	Location *	LS
Category	Earthen Levee			GPS Latitude/Longitude	
				Start	End
Item	Slope Stability			38.998608 °	38.998608 °
				-121.405570 °	-121.405570 °
DWR ID	DWR_RD1001_03_s _ 2013_29				
Comment Code					
S3 : Repair the levee slope damaged by vehicle traffic and prevent access where possible.					
Inspector Comment

Damage caused by vehicles going around the gate. Spring 2013

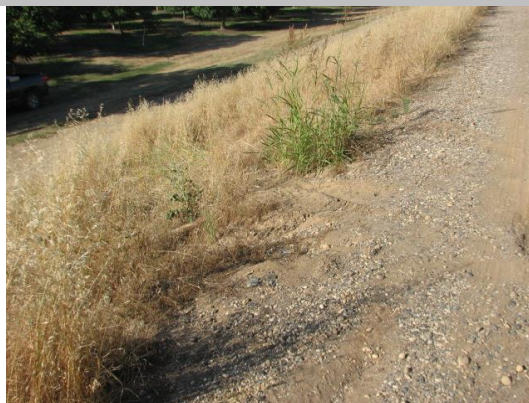
Photo 2 of 2 : SP\_2016\_RD1001\_37\_29\_20160307\_00016.jpg

Damage caused by vehicles. Spring 2013

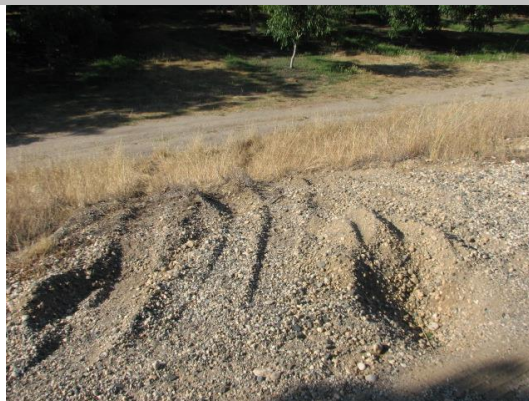
Photo 1 of 1 : SP\_2016\_RD1001\_37\_30\_20160307\_00017.jpg

LM Start	2.28	Rating **	A/W	Issue No.	30
LM End	2.28	Issue Type +	Ma	Location *	LS
Category	Earthen Levee			GPS Latitude/Longitude	
				Start	End
Item	Slope Stability			38.996302 °	38.996302 °
				-121.412285 °	-121.412285 °
DWR ID	DWR_RD1001_03_s _ 2013_30				
Comment Code					
S3 : Repair the levee slope damaged by vehicle traffic and prevent access where possible.					
Inspector Comment

Damage caused by vehicles. Spring 2013

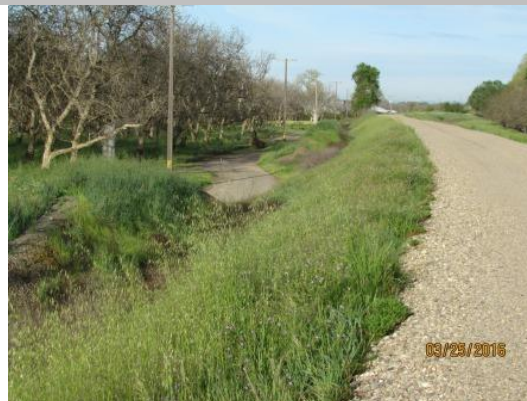
Photo 1 of 1 : SP\_2016\_RD1001\_37\_24\_20160404\_00034.jpg

View of vegetation on landside slope.

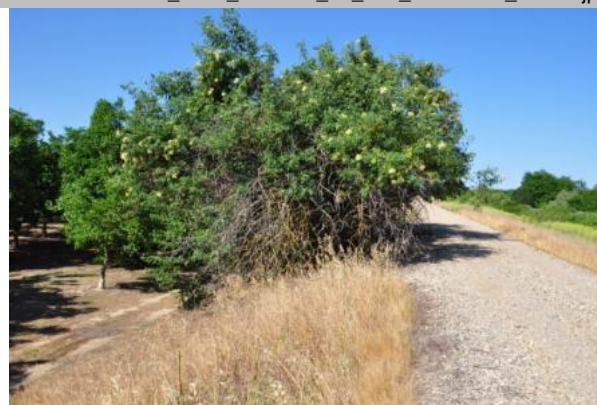
Photo 1 of 1 : SP\_2016\_RD1001\_37\_910\_20160307\_00023.jpg

RD 1001 Unit 3 - L/S slope -Elderberries

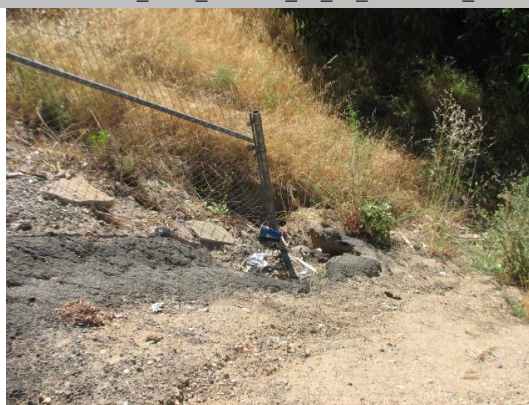
Photo 1 of 1 : SP\_2016\_RD1001\_37\_38\_20160307\_00019.jpg

LM Start	6.47	Rating **	M	Issue No.	38
LM End	6.51	Issue Type +	Ma	Location *	LS
Category	Earthen Levee			GPS Latitude/Longitude	
				Start	End
Item	Erosion / Bank Caving			38.984010 °	38.983955 °
				-121.487420 °	-121.488083 °
DWR ID	DWR_RD1001_03_s _ 2013_38				
Comment Code					
E2 : Schedule repair of erosion site prior to the next inspection.					
Inspector Comment

Erosion caused by run off from the roadway. Spring 2013

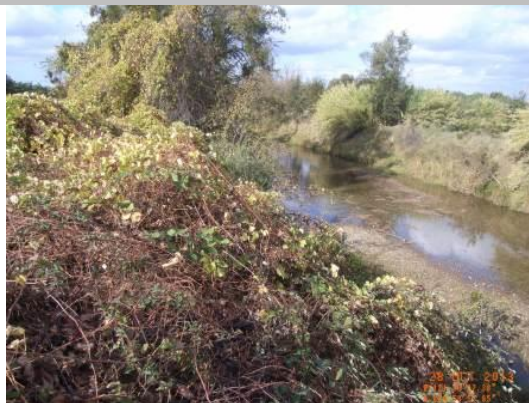
Photo 1 of 1 : SP\_2016\_RD1001\_37\_17\_20160307\_00010.jpg

LM Start	7.22	Rating **	M	Issue No.	17
LM End	7.31	Issue Type +	Ma	Location *	WS
Category	Supplemental			GPS Latitude/Longitude	
				Start	End
Item	2015 USACE Erosion Survey, DRAFT			38.982737 °	38.982572 °
				-121.501144 °	-121.502797 °
DWR ID	DWR_RD1001_03_s_2016_17				
Comment Code					
Inspector Comment					
2008 - Sandy/silty banks with rotational slab failures creating near vertical bank with pop-outs due to tree failures. Narrow berm. 2015: Last observed in 2013. [2015 Site ID: BER_5-7_L]

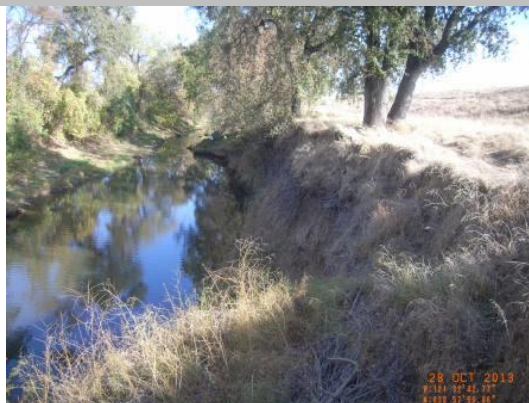
Photo 1 of 1 : SP\_2016\_RD1001\_37\_10\_20160307\_00009.jpg

LM Start	10.36	Rating **	M	Issue No.	10
LM End	10.40	Issue Type +	Ma	Location *	WS
Category	Supplemental			GPS Latitude/Longitude	
				Start	End
Item	2015 USACE Erosion Survey, DRAFT			38.964583 °	38.964010 °
				-121.544967 °	-121.545228 °
DWR ID	DWR_RD1001_03_s_2016_10				
Comment Code					
Inspector Comment					
2011 - Large section of bank has slumped off. RD has flagged and appears to be watching. 2012 - Slopes slightly steeper. 2013 - Minor new erosion observed. 2015: Last observed in 2013. [2015 Site ID: BER_2-5_L]

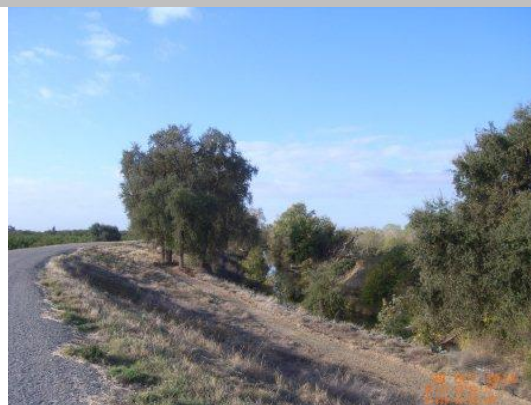
Photo 1 of 1 : SP\_2016\_RD1001\_37\_1\_20160307\_00001.jpg

LM Start	11.08	Rating **	M	Issue No.	1
LM End	11.16	Issue Type +	Ma	Location *	WS
Category	Supplemental			GPS Latitude/Longitude	
				Start	End
Item	2015 USACE Erosion Survey, DRAFT			38.955070 °	38.954227 °
				-121.549528 °	-121.550592 °
DWR ID	DWR_RD1001_03_s_2016_1				
Comment Code					
Inspector Comment					
2011 - Large slumped sections of bank. 2012 - Slopes slightly steeper. 2015: Last observed in 2013. [2015 Site ID: BER_1-9_L]

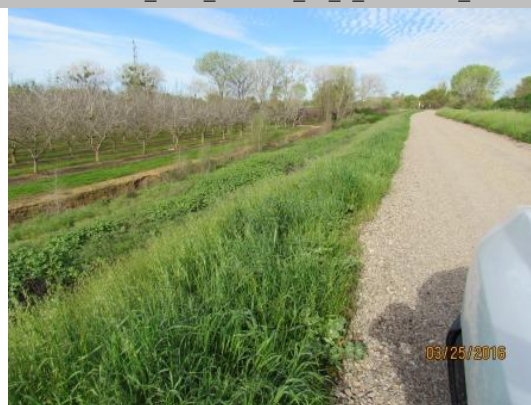
Photo 1 of 1 : SP\_2016\_RD1001\_37\_6\_20160404\_00038.jpg

LM Start	11.15	Rating **	M	Issue No.	6
LM End	11.15	Issue Type +	Ma	Location *	LS
Category	Earthen Levee			GPS Latitude/Longitude	
				Start	End
Item	Vegetation			38.954167 °	38.954167 °
				-121.550304 °	-121.550304 °
DWR ID	DWR_RD1001_03_s_2016_6				
Comment Code					
V2 : Remove the wild growth other than native grasses from the levee slopes.					
Inspector Comment

View of wild growth at landside toe.

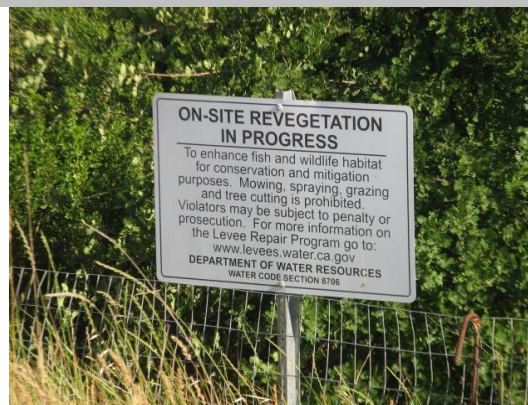
Photo 1 of 1 : SP\_2016\_RD1001\_37\_25\_20160307\_00012.jpg

Revegetation site in progress. Spring 2013

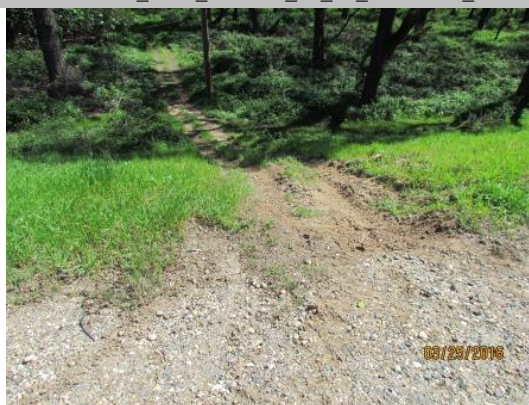
Photo 1 of 1 : SP\_2016\_RD1001\_38\_63\_20160404\_00043.jpg

LM Start	0.18	Rating **	M	Issue No.	63
LM End	0.18	Issue Type +	Ma	Location *	LS
Category	Earthen Levee			GPS Latitude/Longitude	
				Start	End
Item	Slope Stability			38.938534 °	38.938534 °
				-121.567729 °	-121.567729 °
DWR ID	DWR_RD1001_04_s_2016_63				
Comment Code					
S3 : Repair the levee slope damaged by vehicle traffic and prevent access where possible.					
Inspector Comment

Landside slope erosion caused by vehicles.

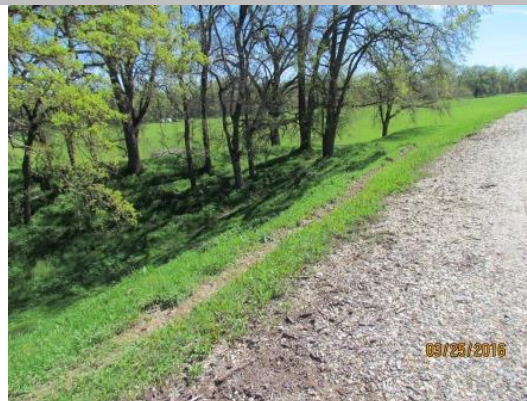
Photo 1 of 1 : SP\_2016\_RD1001\_38\_64\_20160404\_00044.jpg

LM Start	0.37	Rating **	M	Issue No.	64
LM End	0.37	Issue Type +	Ma	Location *	LS
Category	Earthen Levee			GPS Latitude/Longitude	
				Start	End
Item	Animal Control			38.935903 °	38.935903 °
				-121.567250 °	-121.567250 °
DWR ID	DWR_RD1001_04_s_2016_64				
Comment Code					
A2 : Repair the levee slope damaged by livestock and prevent large animal access.					
Inspector Comment

Livestock trail cut into landside slope.

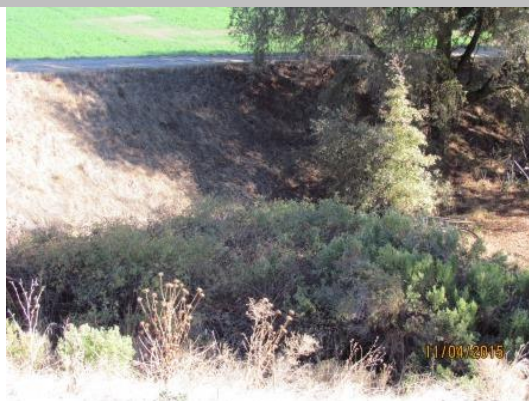
Photo 1 of 1 : SP\_2016\_RD1001\_38\_31\_20160307\_00018.jpg

View of the tall vegetation at the landside levee toe.

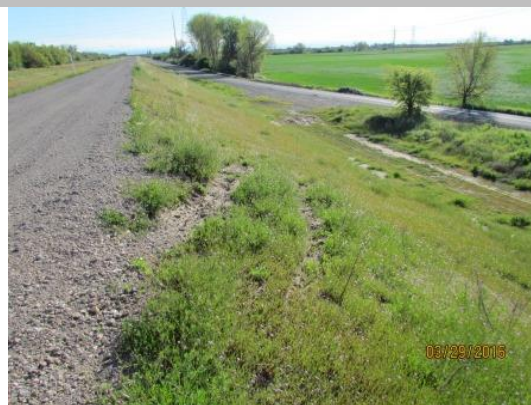
Photo 1 of 1 : SP\_2016\_RD1001\_38\_75\_20160404\_00045.jpg

Landside slope damage caused by a vehicle.

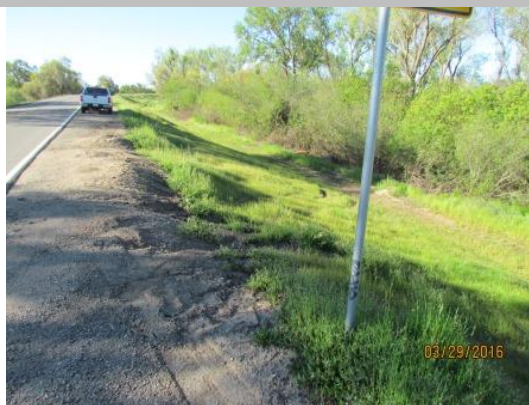
Photo 1 of 1 : SP\_2016\_RD1001\_38\_78\_20160404\_00046.jpg

Ruts on waterside slope due to vehicles.

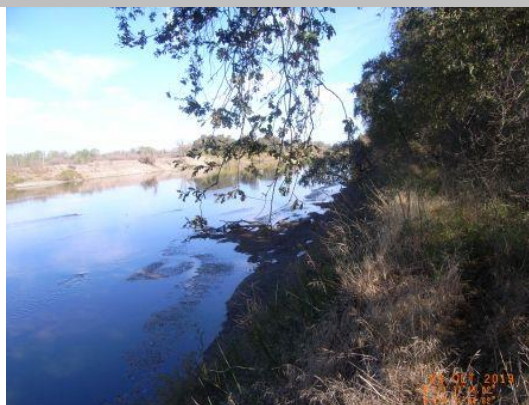
Photo 1 of 1 : SP\_2016\_RD1001\_38\_5\_20160307\_00005.jpg

LM Start	6.42	Rating **	M	Issue No.	5
LM End	6.51	Issue Type +	Ma	Location *	WS
Category	Supplemental			GPS Latitude/Longitude	
				Start	End
Item	2015 USACE Erosion Survey, DRAFT			38.865875 °	38.864706 °
				-121.619983 °	-121.620813 °
DWR ID	DWR_RD1001_04_s_2016_5				
Comment Code					
Inspector Comment					
2011 - Tall slumping sections. Scour around trees has exposed most of the roots. 2015: Recent large slope failure observed. [2015 Site ID: FHR_6-0_L]

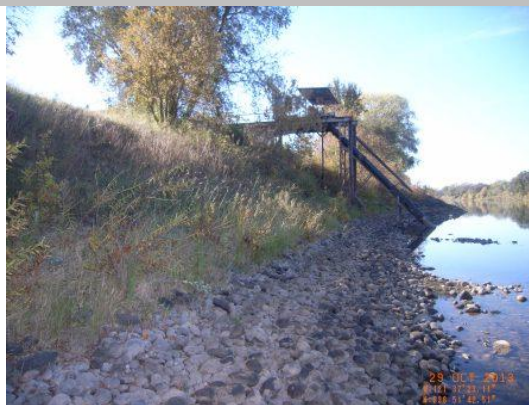
Photo 1 of 1 : SP\_2016\_RD1001\_38\_4\_20160307\_00004.jpg

LM Start	6.57	Rating **	M	Issue No.	4
LM End	6.77	Issue Type +	Ma	Location *	WS
Category	Supplemental			GPS Latitude/Longitude	
				Start	End
Item	2015 USACE Erosion Survey, DRAFT			38.863946 °	38.861558 °
				-121.621388 °	-121.623316 °
DWR ID	DWR_RD1001_04_s_2016_4				
Comment Code					
Inspector Comment					
2011 - Large slumped sections on the lower bank. 2012 - New cracks observed. 2015: No observed changes. [2015 Site ID: FHR_5-8_L]

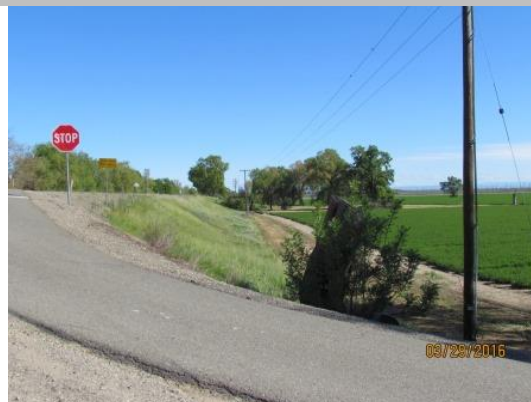
Photo 1 of 1 : SP\_2016\_RD1001\_38\_83\_20160404\_00049.jpg

View of tree stump on the landside toe.

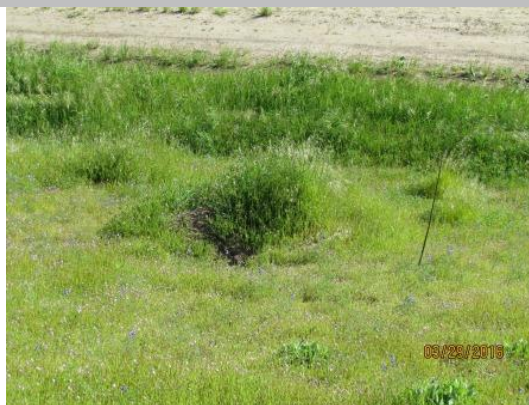
Photo 1 of 1 : SP\_2016\_RD1001\_38\_38\_20160404\_00048.jpg

View of rodent hole on landside slope.

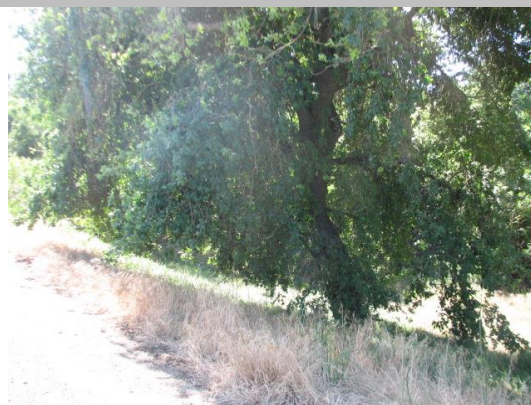
Photo 1 of 1 : SP\_2016\_RD1001\_38\_151\_20160307\_00023.jpg

Trees need to be trimmed up at least 5 feet. Spring 2013

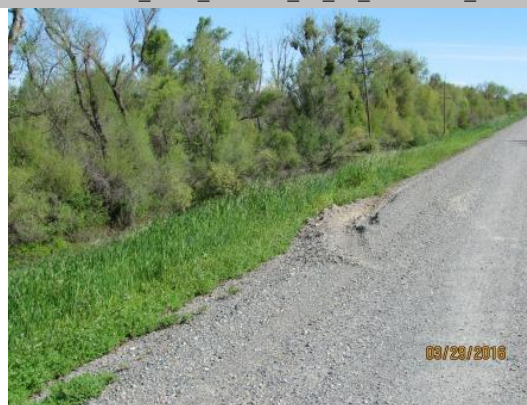
Photo 1 of 1 : SP\_2016\_RD1001\_39\_20\_20160404\_00031.jpg

Vehicle rut on landside crown.

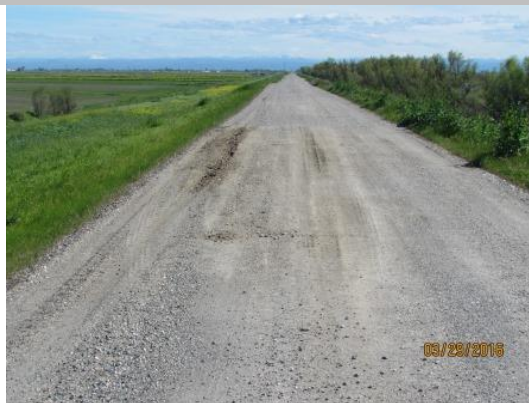
Photo 1 of 1 : SP\_2016\_RD1001\_39\_21\_20160404\_00032.jpg

Vehicle ruts on levee crown where there is minimal aggregate.

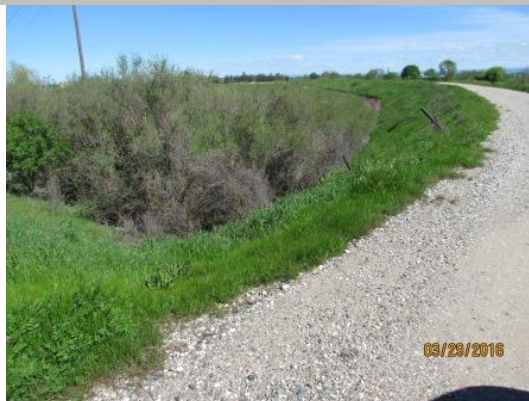
Photo 1 of 1 : SP\_2016\_RD1001\_40\_18\_20160404\_00034.jpg

View of trees that need to be trimmed for visibility on the landside looking upstream.

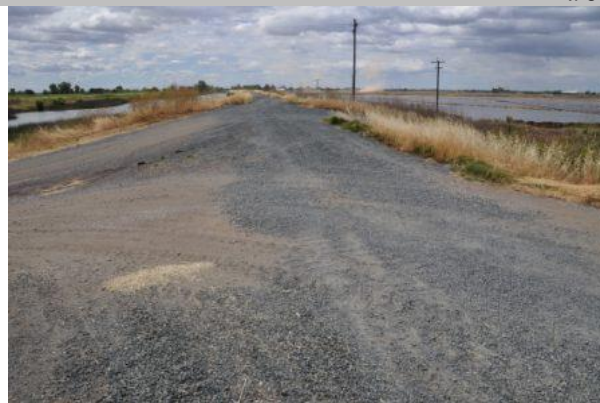
Photo 1 of 1 : SP\_2016\_RD1001\_40\_8\_20160307\_00005.jpg

RD 1001 Unit 6 - Levee Crown - Subsidence due to vehicle traffic.

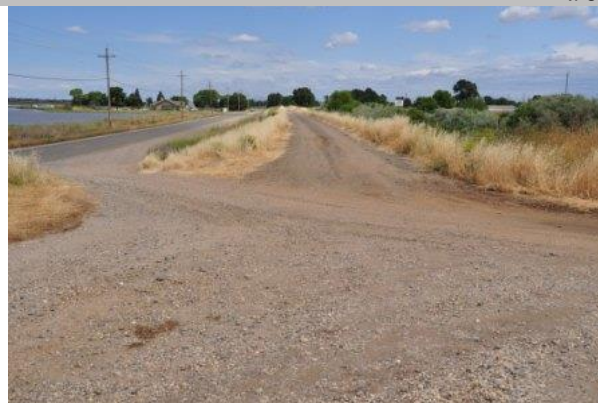
Photo 1 of 1 : SP\_2016\_RD1001\_40\_7\_20160307\_00004.jpg

RD 1001 Unit 6 - Levee Crown - Subsidence due to vehicle traffic.
